# **PREVENTING AND CONTROLLING WATER-CONDUCTING ROT IN BUILDINGS**

A. F. Verrall

**SOUTHERN FOREST EXPERIMENT STATION**

**Forest Service, U.S. Department of Agriculture**

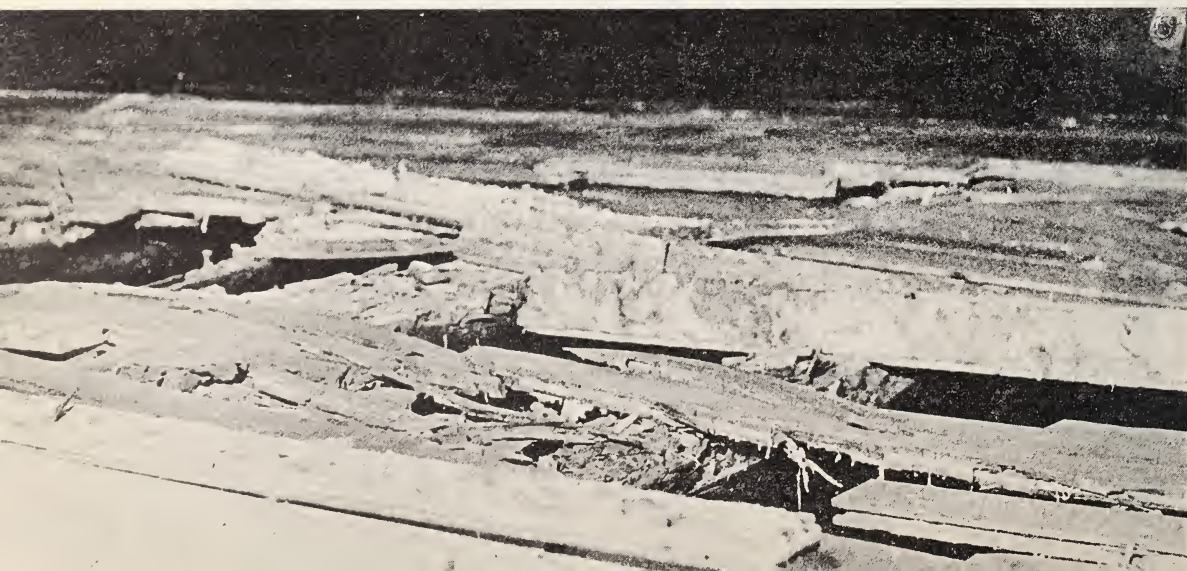
When a water conductor occurs in a building, the extent and rapidity of attack may be spectacular (6, 9). Poria causes a brown cubical rot, usually starting in the substructure--the sills, first-floor joists, nailing strips, wall plates, etc. (fig. 1). Later it may work up into the walls and even attack the second floor. By this time all structural and trim items in the area of the original attack may be damaged. Oftentimes owners are unaware of the attack until a floor fails, doors settle, sunken areas appear in baseboards, or a yellowish-white fungus felt appears under a rug or in a cupboard. When the wall or floor is opened for repairs, extensive yellowish-white mycelial mats (fig. 2) are usually found between sheathing and building paper or between two wood surfaces as finish and subfloors.

Figure 1. --Flooring badly decayed by Poria.

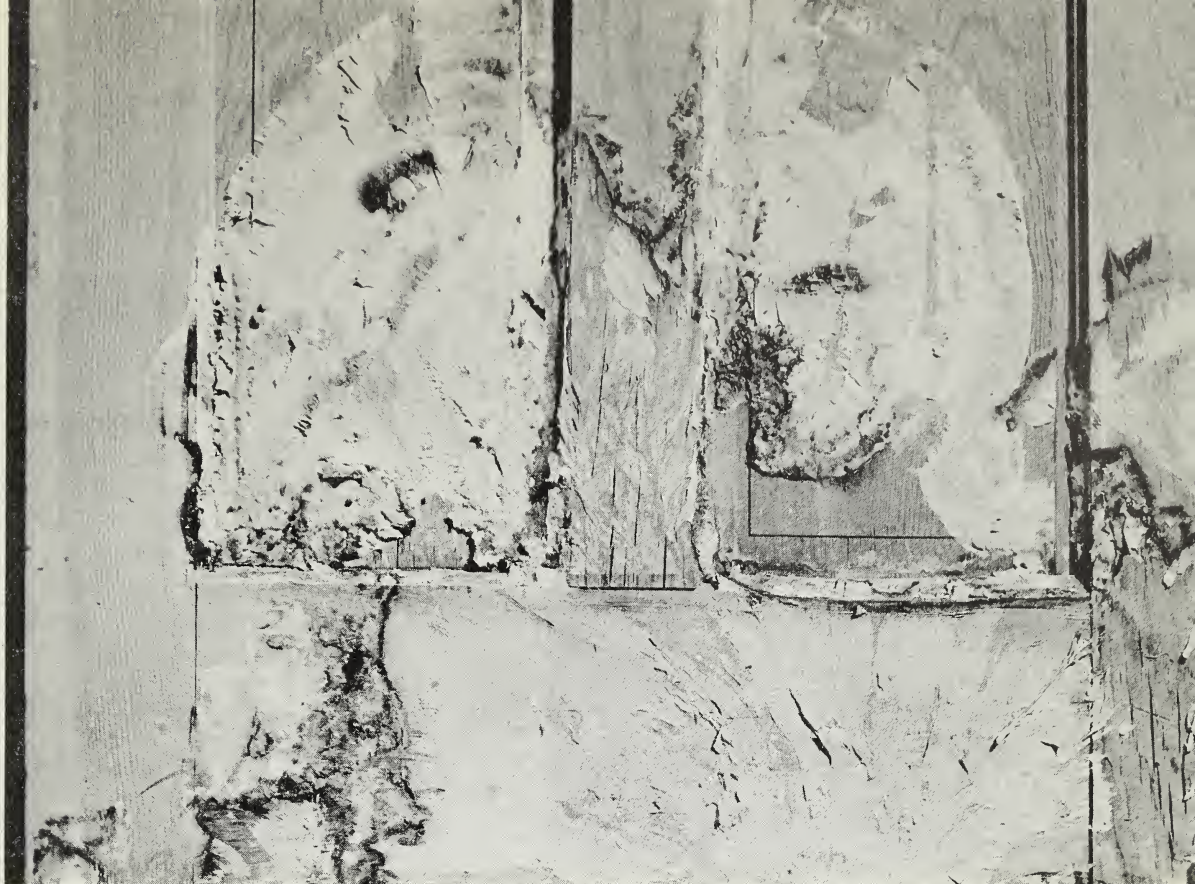
Figure 2. --Mycelial growth of Poria on the back of a wood panel.

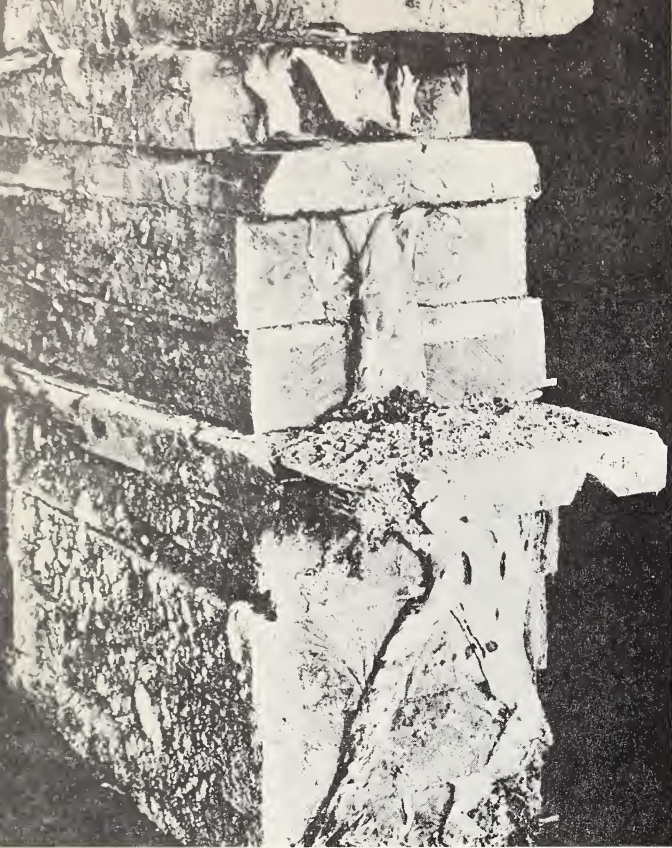
When extensive damage occurs, rhizomorphs (water-conducting strands) from a small fraction of an inch to 2 inches in diameter can usually be found (fig. 3). They extend from the soil or other constant water source up into the wood structure. It is these rhizomorphs and well-developed mycelial fans that permit Poria to conduct water to wood normally too dry to decay. When decay is more restricted, definite rhizomorphs may be lacking but the mycelial mats show a tendency to form strands. Laboratory studies<sup>2/</sup> have shown that Poria can conduct water at least 5 feet up wood columns. Observations in buildings indicate that this fungus can conduct water at least 20 feet horizontally and 12 feet vertically.

Figure 3. --Water-conducting rhizomorphs growing on the ends of piled lumber.

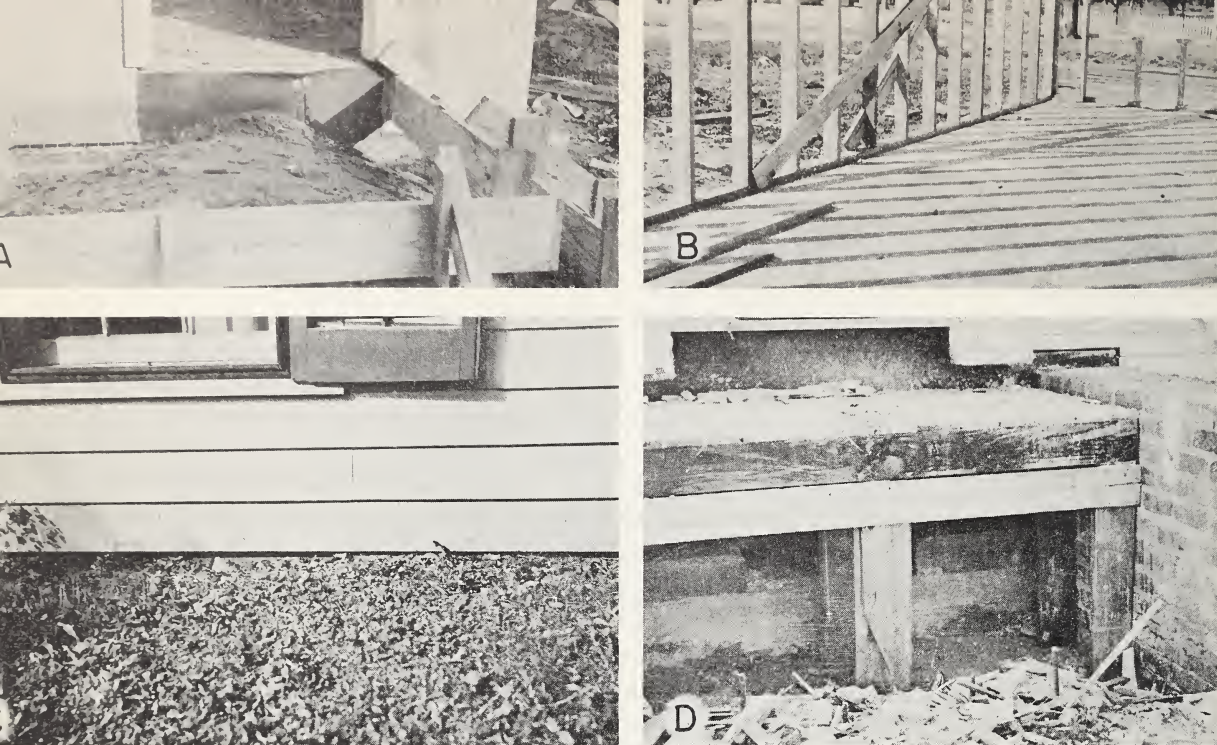
(1) Dirt-filled porches with an untreated sill or header in contact with the dirt fill or separated from it only by asphalt-impregnated sheathing paper (fig. 4A). The dirt-filled porch has led to so much decay and termite trouble that extreme caution should be exercised in including this type of construction in a building. It is much safer to use a self-supporting slab with the subslab area open to the crawl

Figure 4. --Some common practices leading to attack by water-conducting fungi. A, The dirt fill for this porch is separated from the untreated sill only by sheathing paper. B, Non-waterproofed groundline concrete slab. C, Untreated wood in contact with soil. D, If these forms are left after the stoop slab is poured, they will make a wooden contact between the soil and the sill of the house.

(3) Untreated wood on moist groundline concrete slabs (fig. 4B). Even when water-conducting rot does not occur, this condition usually leads to floor buckling and damp living quarters. Poria can become established in wall plates and nailing strips and can secure enough water from the soil through the slab to cause extensive decay. When severe water-conducting rot is associated with wooden floors and walls on a damp concrete slab, there is no sure way of control except to remove the floor, replace the wall plates with pressure-treated wood, and add a moisture-proof membrane to the slab, being sure that it extends under the wall plates. New nailing strips and subflooring should be pressure-treated. This is the most expensive and discouraging type of Poria attack to correct. Many of the houses attacked in this way have been torn down completely and replaced with other types of construction. When the attack is not too severe there is a possibility that control could be secured by removing wooden floors and replacing badly damaged wood in the walls, using treated plates. Then the unattacked plates could be given some protection by flowing 5 percent pentachlorophenol over and under them. A non-wood floor would then be used. There is no record of such a treatment but it should stand a good chance of success.

(4) Sheathing, siding, and trim in contact with the soil (fig. 4C). In most cases this was due to careless grading or the building up of flower beds. Rich, mulched flower beds seem to be an ideal place for the rooting of a well-developed rhizomorph system. As long as siding and trim is kept to the usually recommended minimum of 6 inches from the soil, there should be no danger of its being an entrance point for Poria. A number of houses were found, including one with heavy Poria attack, in which the sheathing was brought down to the soil to act as a support for metal lath and stucco. The wood between the stucco and the foundation piers could be removed only by removing the stucco.

(6) Wooden forms left on foundations, steps, and porch slabs (fig. 4D). Although only two cases were traceable to this condition, the common practice of leaving forms in hidden places is risky. The cost of

space or cellar. When the slab is a step or two lower than the house floor the fill may be entirely below the wood, in which case there is little danger. Attack may also be prevented by the insertion of a continuous non-corrosive metal shield. Such a shield should extend down from under the siding, over the outside and underside of the sill to the crawl space, and there should bend downward at  $45^{\circ}$  for 2 inches. There is also a possibility that attack of both decay and termites can be prevented by treating the fill with fungicides and insecticides before the slab is poured. Tests on the effectiveness of soil fungicides have been started. The easiest way, however, is to avoid the dirt fill.

When attack involves a dirt fill the usual correction consists of removing a section of the foundation and excavating the fill away from the sill. The excavation should be sufficient to permit crawling along the sill for inspection. The concrete slab and foundation exposed by the excavation should be scraped clean and painted or sprayed with

creosote or with 5 percent pentachlorophenol in a petroleum oil. In one case a 12-inch strip of the porch slab was removed next to the sill and enough fill removed to insert a new pressure-treated sill. The excavation was filled with creosote-treated cinders and the slab was repaired. This, however, did not leave as finished-appearing a job as the usual excavation from the underside.

Because of the difficulty and expense of correcting an attack in wooden houses laid on groundline slabs, care should be taken to insure that the construction is safe from the start. Concrete slabs for houses should be elevated so the top surface is 12 inches above grade, the slab poured on a layer of gravel, and a water-proof membrane used either below or on top of the slab. No grade stakes should be left in the slab. When these recommendations are followed, there usually is no trouble with decay. Nevertheless it is best also to use treated wall plates, nailing strips, and subflooring.
